**Location:** Napa Valley, CA

AMI system reduces boron and produces high quality water for premium wine production

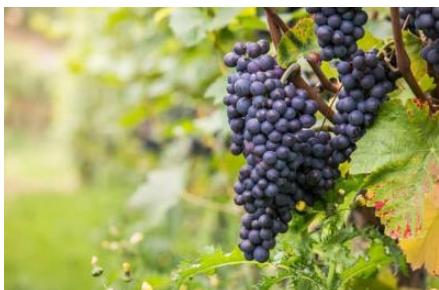
Applied Membranes Inc built a state-of-the-art **30 GPM (7 m3/h)** water treatment system in one 40-ft container. The double pass Reverse Osmosis (RO) system removes boron to acceptable levels while maintaining essential mineral balance for vine health. The permeate from the 2-pass RO system, with pH adjustment to facilitate boron removal, achieved the desired boron level of less than 0.5 mg/l.

- Double pass RO system
- One 40-ft container insulated and air conditioned
- Three 24x72 greensand media filters
- Chemical injection units
- Pumping distribution system
